Technical Service Bulletin

No.LA501-030V2
26
September 2006

Subject/Concern:	Discovery 3/LR3 - Washer Reservoir Leak

Models:		
Discovery 3 / LR3		VIN- range: Up to 6A408013

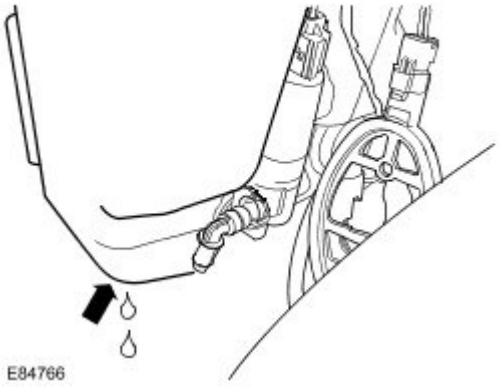
Cause: A manufacturer process error has resulted in a weak seam joint at the base of the washer reservoir.

1 . Inspect the washer reservoir to confirm the leak is from the seam joint at the base of the washer reservoir.
